# L.P. #1: 9307 Union Drive Strathroy-Caradoc

Concession 6, Lot 23
(former Township of Caradoc, Middlesex County)

# Scoped Heritage Impact Assessment

Prepared for Canadian Solar Developers
by Robinson Heritage Consulting

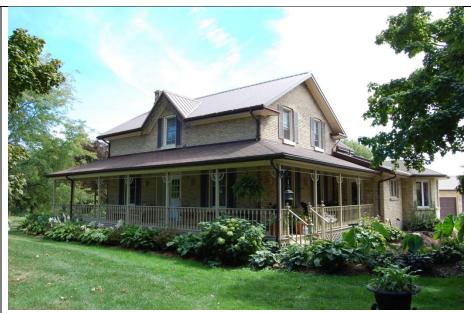
Figure 7 – Farmhouse, viewed from lane. (Photo: RHC, Aug 2012)

As one approaches along the laneway, the visual focus of the property is its 1 % - storey, brick Ontario farmhouse. The massing and style of this dwelling was a popular design in rural domestic architecture in the early  $19^{th}$  to the early  $20^{th}$  century. The distinguishing features are the T-shape plan footprint with the main block of the house having a side gable main roof with return eaves and with a smaller front gable over the front door. A perpendicular tail extends to the rear with a side door leading out into a side porch. The central front door has a transom and is flanked by sidelights.

The historical farmhouse was built with white (yellow) clay brick which was a common building material in mid-19<sup>th</sup> century. The type of clay used to make this type of brick is found in the London and Middlesex area and, therefore has become a typical feature of so many Victorian era homes and buildings.

The brickwork was laid using a common bond (header course at every fifth course) which indicates that this is quite likely a double-brick house. The window head over the front upper window is a segmental arch of soldier brick. A white (yellow) brick chimney shaft rises from the north roof ridge and from the roof ridge of the tail.

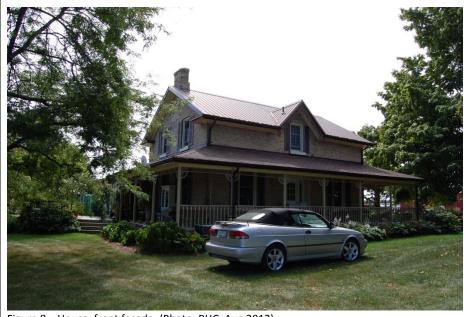
Figure 8 – House, front facade. (Photo: RHC, Aug 2012)

It is not known if the existing hip roof, wraparound verandah has been built to recreate a similar previous verandah or if it extended what was likely a full width front porch.

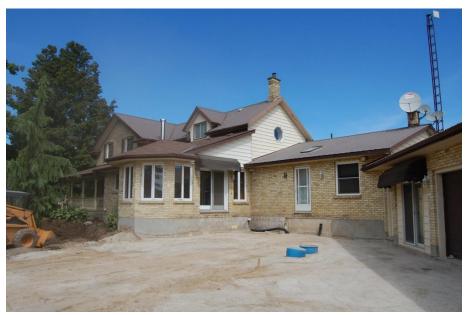
Figure 9 – Tail and rear additions. (Photo: RHC, Aug 2012)

The farmhouse has had single-storey additions made to the tail at the side and rear including a hip roof corner bay and a gable roof section connecting to a gable roof double garage (Figures 9 and 10).

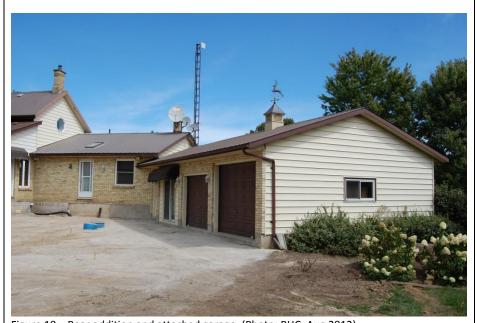
Figure 10 – Rear addition and attached garage. (Photo: RHC, Aug 2012)

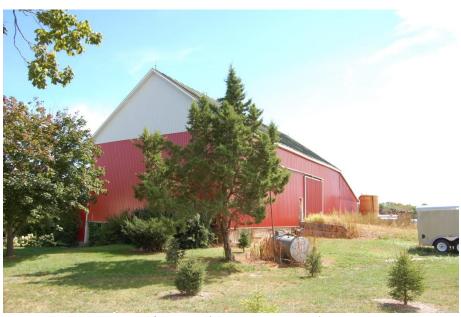
Figure 11 – Bank barn, viewed from west. (Photo: RHC, Aug 2012)

A large, timber frame bank barn is located south of the farmhouse. This type of barn with a gable roof is likely to have been raised in the later 19<sup>th</sup> century and the gambrel barn roof did not become popular until the mid-20<sup>th</sup> century. Another clue as to the barn's age is the white (yellow) brick foundation walls and the fieldstone foundation quoins (or corners).

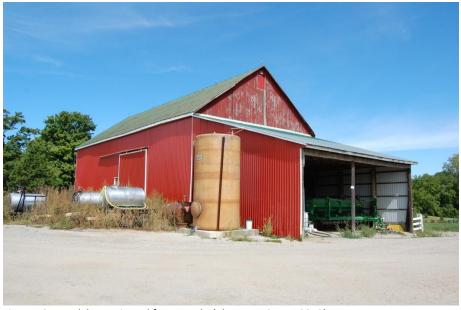
Figure 12 – Bank barn, viewed from south. (Photo: RHC, Aug 2012)

The barn has been clad in vertical metal siding. The only areas where the vertical wood barn board cladding is visible are the southeast gable wall (Figure 12) and under the roof on the bank side of the barn (Figure 13).

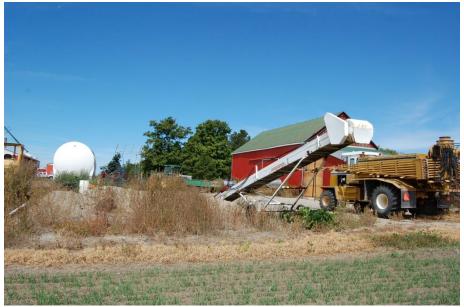
Figure 14 – Bank barn, viewed from a point approximately 39 meters south of barn. (Photo: RHC, Aug 2012)

The array would be located on what is now cultivated lands to the southeast of the timbre frame bank barn (Figures 17 and 18). The northwest corner of the array would be approximately 39m from the closest corner of the lean-to rear portion of the bank barn. The view from the northwest corner of the array back to the barn and toward the house is approximated in Figure 14.

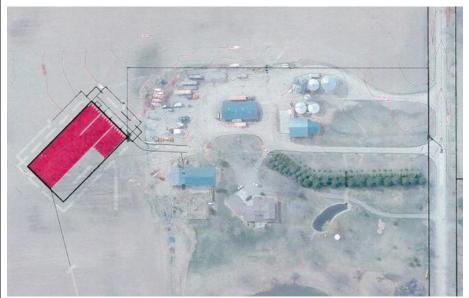
Figure 15 - Site Plan indicating proposed placement of solar array installation. (Image provided by Exp Inc. for Future Solar Developments Inc., 2012)

The arrays are to be installed on agricultural fields where the client has established long term leases. The client proposes to install a solar panel array with a footprint of  $37m \times 67m$  (~0.6 acres) (Figure 15) and panels with a height of approximately 1.5 to 1.8 meters from the ground (Figure 16).

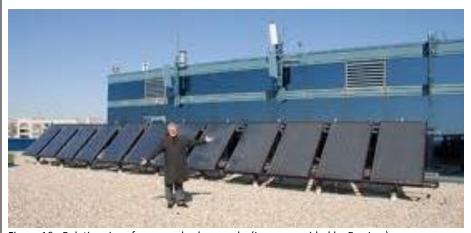
Figure 16 - Relative size of proposed solar panels. (Image provided by Exp Inc.)

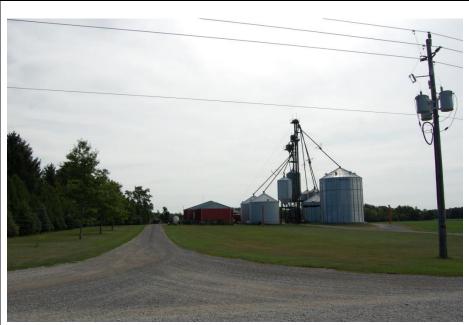
Figure 20 - View southeast from Union Drive. (Photo: RHC, Aug 2012)

Figures 20 and 21 show the current view from Union Drive past the farm complex toward the proposed solar array. The solar array would not project visually above the tree line on the horizon.

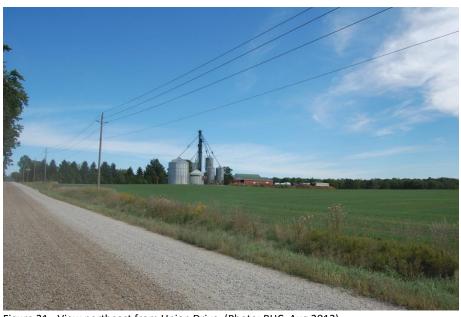
Figure 21 - View northeast from Union Drive. (Photo: RHC, Aug 2012)
